Mooring system integrity a hot button question

Series of failures sparks industry investigation into materials and current manufacturing processes

TECHTALK

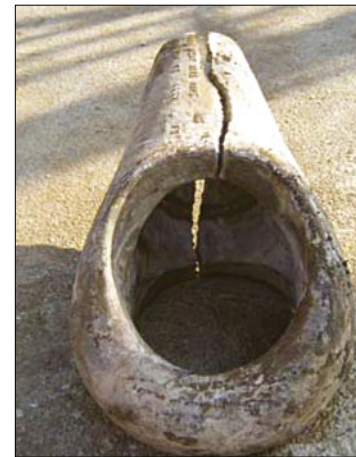
Shaker: mooring socket failures add to shackle woes Photo: MMS

At Kikeh, an eight-inch shackle weighing one tonne and sited at a seabed anchor pile failed.

In the second incident cited by the MMS, two sockets in a mooring array for a deep-water drilling rig failed under moderate loading. Testing of the remaining

sockets found that others were also defective and a number of them failed catastrophically at less than specification loading.

Among their conclusions, the MMS and the US Coastguard noted: "In both cases the manufacturing procedures are thought to have been defective. Heat treating after casting apparently resulted in a metal unable to meet standards for material toughness."

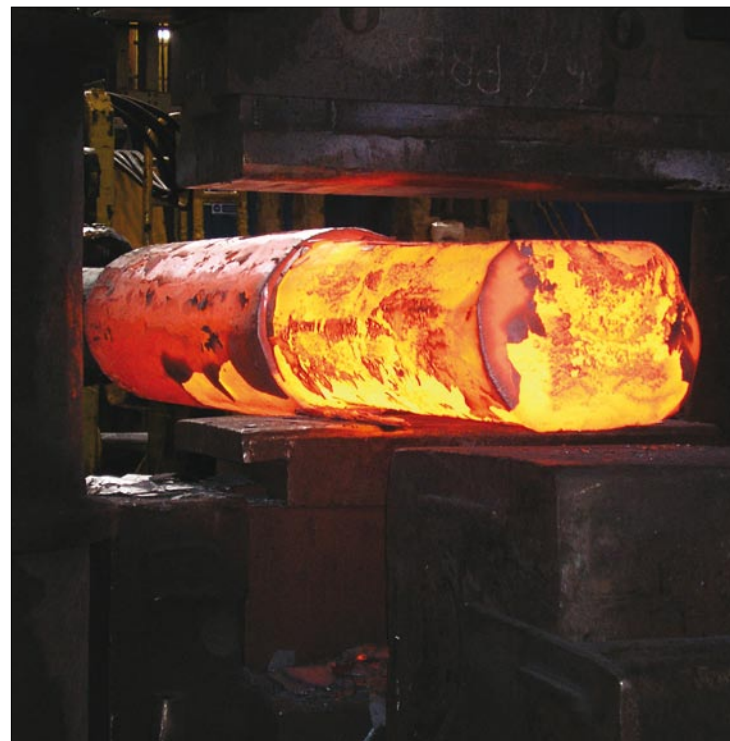
Back to basics: new research project aims to gain better understanding of the integrity of mooring components formed by the hot deformation of steel that is the forging process Photos: FIRST SUBSEA

The objective of the research project is fully to understand what happens during the forging process and so to better characterise the micro-structure of forged metals.

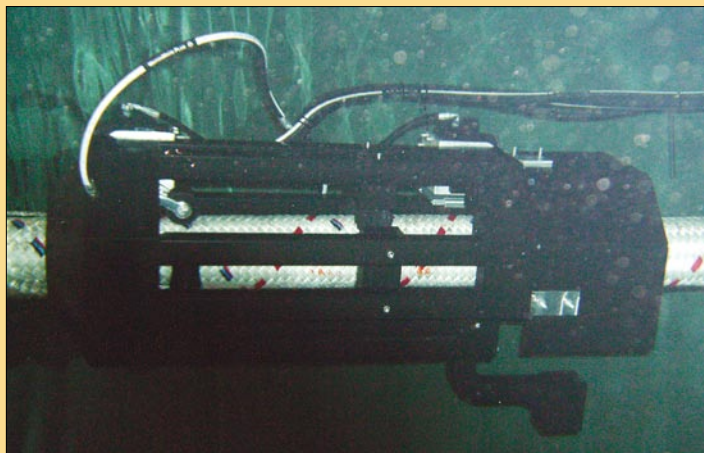
Inspection system: the sled is towed by an ROV, cleaning line as it goes and recording dimensions to check for any signs of potential deterioration

The system assesses the condition of fibre or wire rope moorings while they are in-service, still in the water. It centres on a frame equipped with a hydraulic sled and fixed cameras that is deployed onto the mooring line by an ROV.

There, a hydraulic sled encircles the rope and clasps shut.

As the frame is towed along the rope by the ROV, the sled removes marine growth using

a combination of mechanical plough, high-pressure water jetting and an annulus of brushes.

At the same time, rope dimensions are recorded and compared with manufacturer's specifications to identify any changes in cross-section.

The video signal is transmitted to a topside computer suite where algorithms measure the rope at approximately 50 millimetre increments. These measurements are indicators of potential deterioration, which can increase the risk of failure in a mooring system.
